**PITTSFIELD MILL DAM**

**NH 00120**

**PHASE I INSPECTION REPORT  
NATIONAL DAM INSPECTION PROGRAM**

**AUGUST 1978**

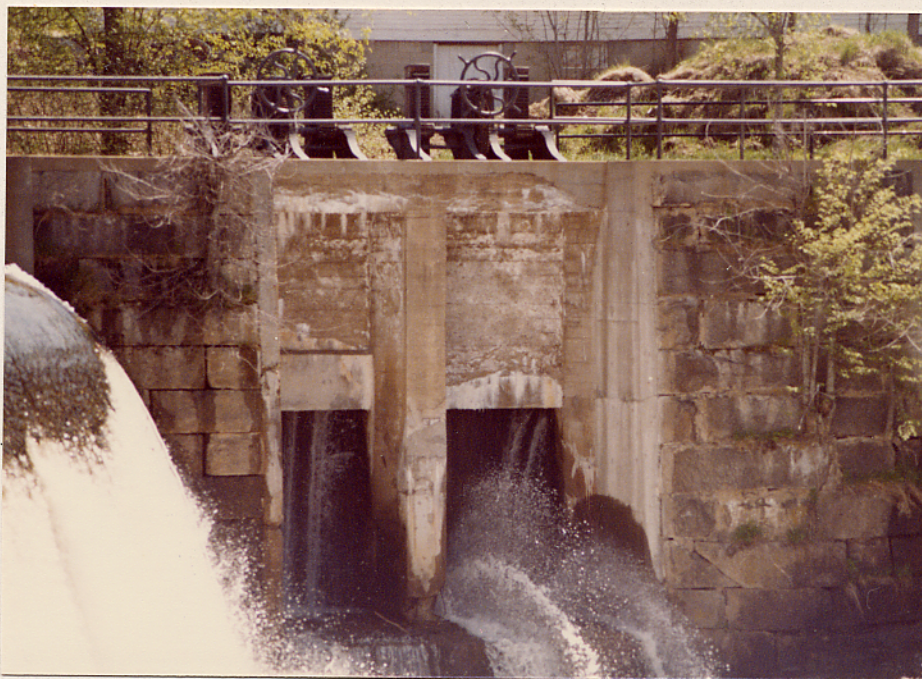
- The fascia above the sluice gage openings has spalled with considerable random cracking, efflorescence and stalagmites.
- The outlet side of the intermediate support wall between the sluice gates shows evidence of severe localized concrete erosion. Concrete has completely eroded at the base of this wall for a depth of 15 inches and a height of 18-inches. Considerable cracking and efflorescence is in evidence adjacent to this location. This wall shows evidence of prior repairs.

The concrete deterioration of the outlet side of the intermediate wall supporting the sluice gates can be attributed to cavitation. Other minor spalling, checking and efflorescence can be attributed to moisture intrusion and the effects of alternate freeze and thaw cycles. The subsidence of the soil foundation for the surface slab of the water control structure can be attributed to improper compaction.

1. Low level gates showing deterioration of concrete at bottom of center wall

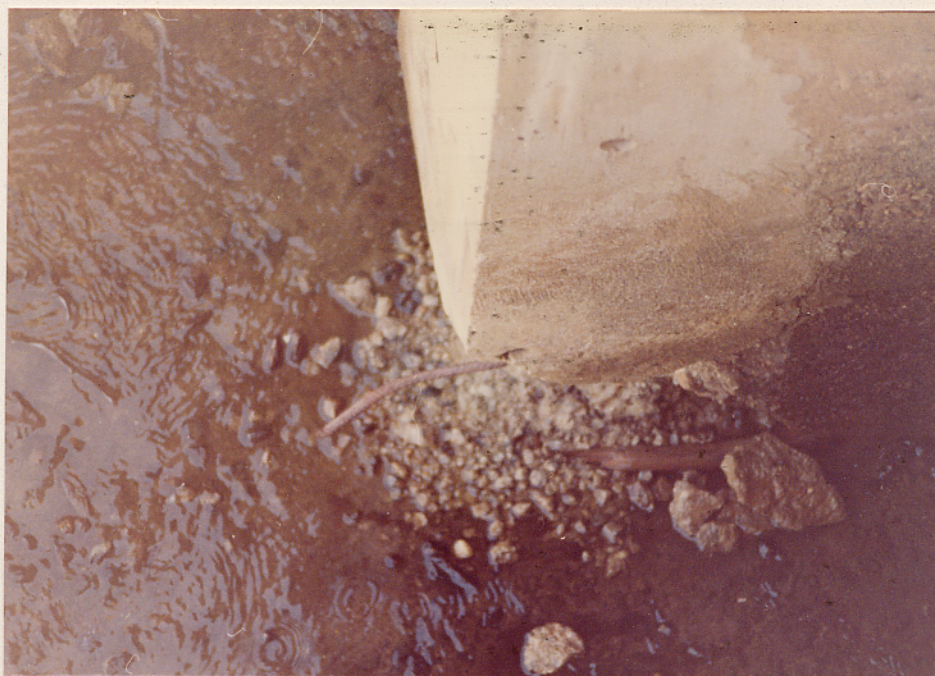
2. Detail of Photo 1

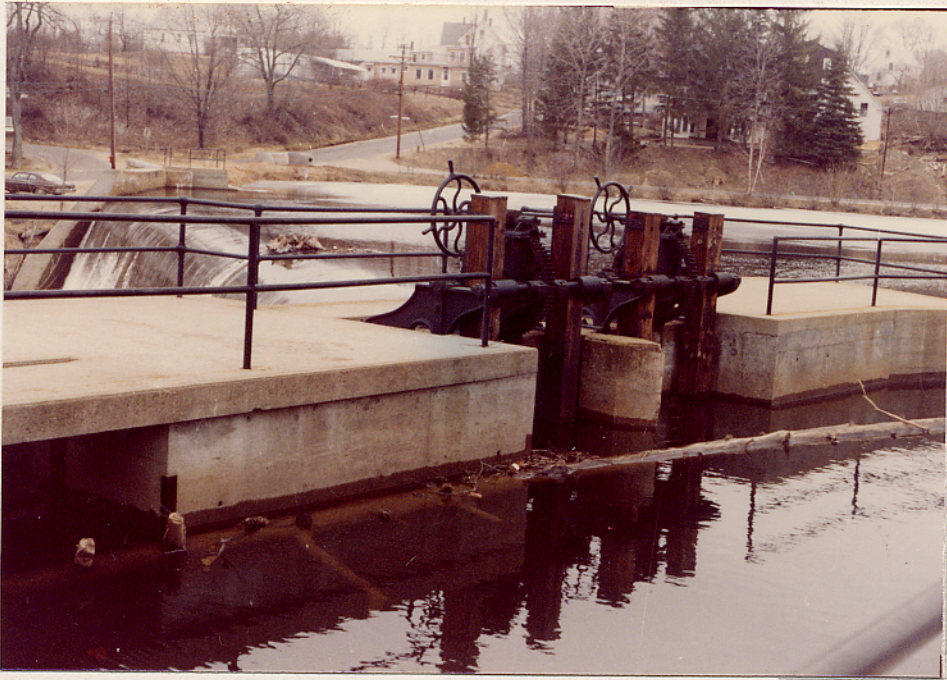
- The timber sluice gates and operating mechanisms are in good condition however the operation of the sluice gates are difficult. The joint efforts of the representative of NHWRB and three members of the inspection team opened the most easterly gate (6-inches) in five minutes. The closing procedure required the same effort. After proceeding with the operation of the west gate and after unseating, the gate became inoperable due to shaft misalignment. The misalignment was caused by stripped bolts fastening one of the bearing assemblies. Inspection revealed that this shaft misalignment has been subjected to prior maintenance.

3. View from upstream of low level sluice gates

The draw down capacity of the dam is seriously deficient because of the inoperative gate. The westerly gate shaft bearing blocks should be repaired within the recommended time frame of 1 to 2 years.

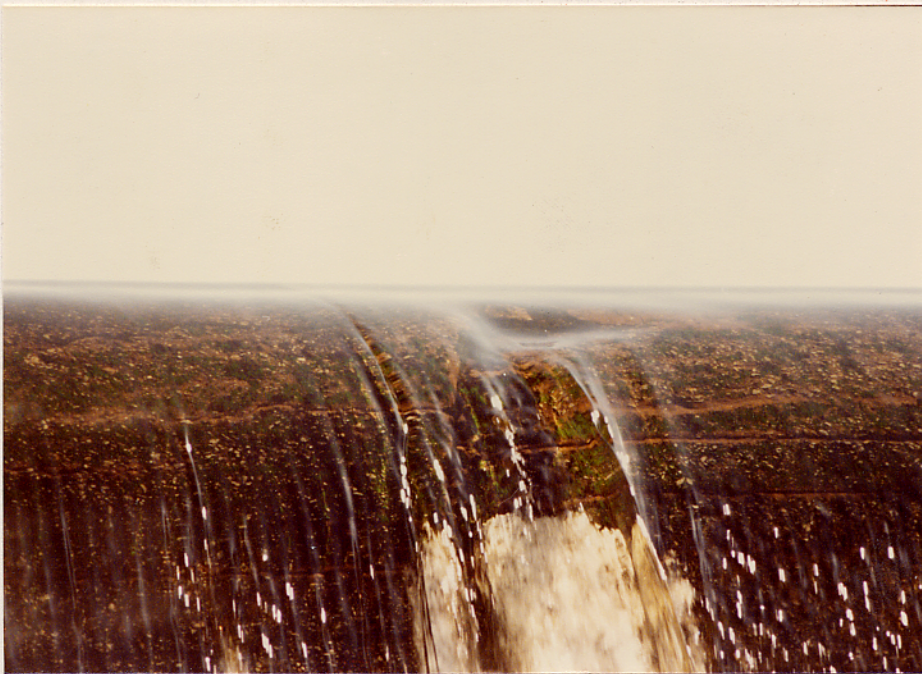
It was observed that a continuous open horizontal joint approximately 4 feet below crest elevation extends from the west wingwall for approximately 60% of the length of the crest. It is estimated that this joint is 1-inch in width. Further observations have revealed localized spalling on the downstream face of the spillway.

The open horizontal joint extending over a major portion of the spillway is the result of cavitation at a construction joint resulting from prior construction activities. The spalling of the vertical joints between the spillway and adjacent westerly training wall and the east abutment can be attributed to cavitation at construction joints at these locations. Surface spalls on the downstream face of the spillway can be attributed to cavitation.

4. Spillway showing crest deterioration at mid-dam

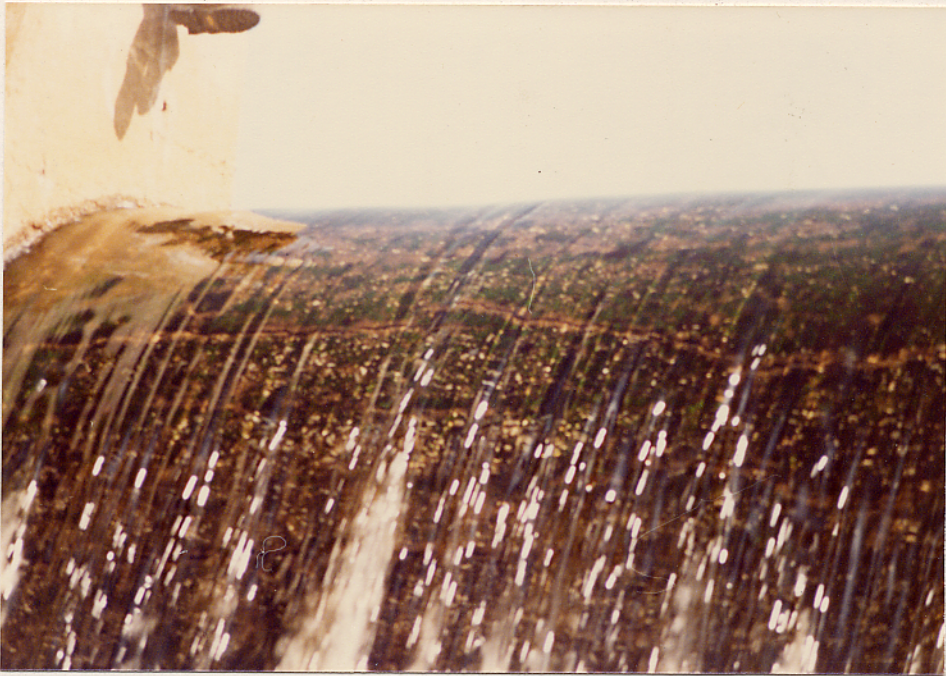
5. Spillway showing crest deterioration at right abutment

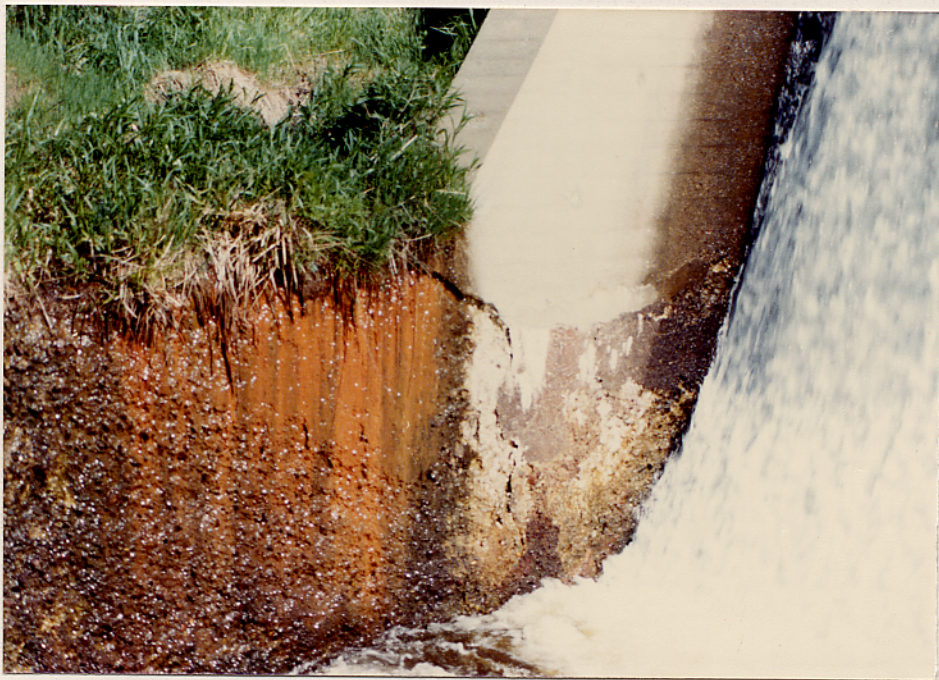
Continuous seepage flows over this wall from a location 10 feet south of the dike, and 5 feet up slope from the dike. Deep holes are present, possibly from rodent infestation, although this zone has historically evidenced continuing seepage. Further surface draining from the road is also directed to the end of the training wall, aggravating the staining and concrete erosion.

6. View from downstream showing effects of seepage through right embankment and training wall

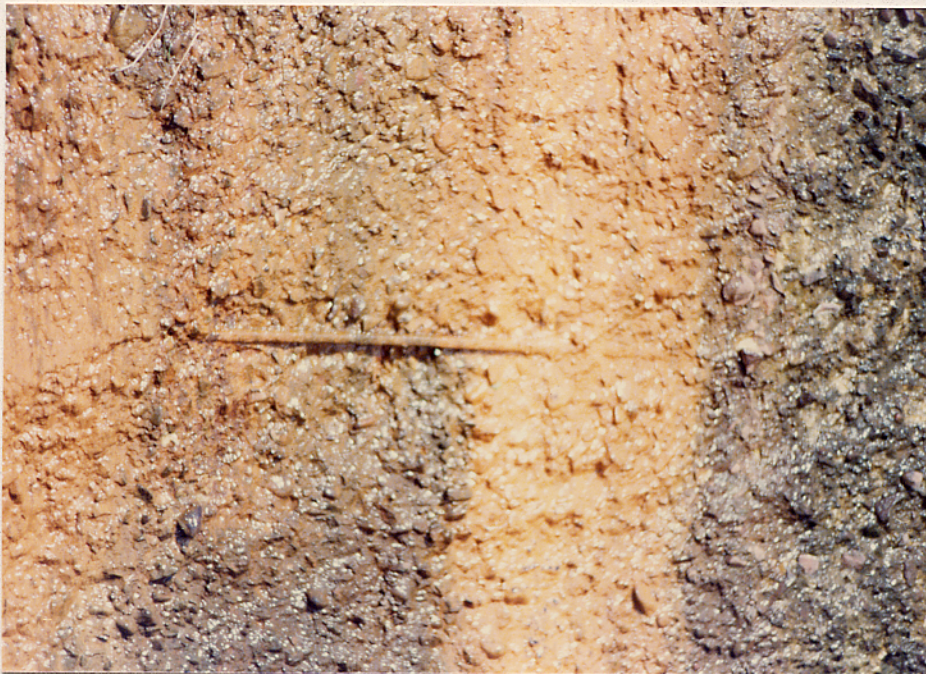
The connection between the training wall and the westerly end of the spillway is severely spalled. The joint between these structures has eroded to a depth of approximately 6 inches by 8 feet in vertical height. This opening is up to 1-inch in width. The low training wall located in line with the end of the spillway is severely scaled and reinforcing steel is exposed and badly stained.

The spalling, checking, and efflorescence on the downstream face of the retaining wall adjacent to the spillway can be attributed to seepage and alternate freeze and thaw cycles. The spalling and exposure of reinforcing steel of the "L" shaped wall can be attributed to alternate freezing and thawing cycles accelerated by constant seepage flowing over a portion of this wall.

7. Details of photo 6 including exposed rebar
